A journey with the FlashCam prototype body

Text and pictures: Arno Gadola, Physik-Institut, University of Zurich

September 8, 2015

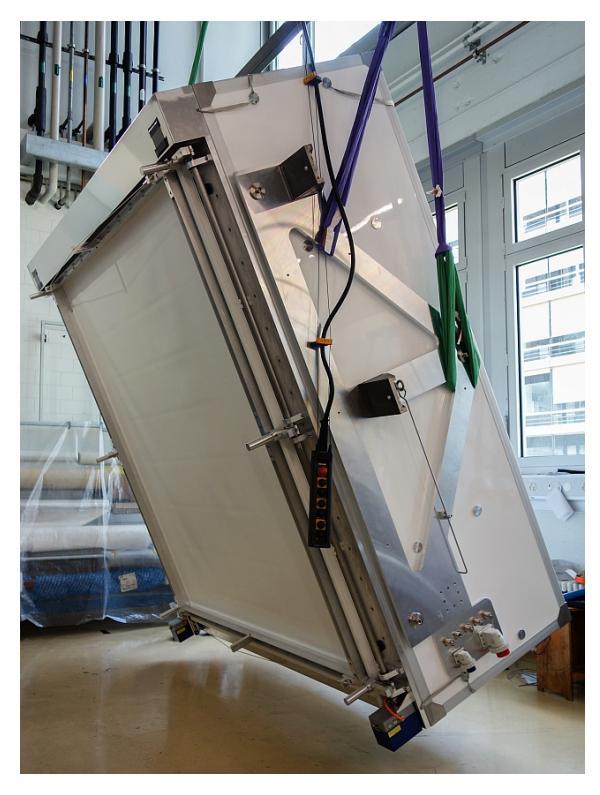
Figure 1: Side view of the FlashCam body with closed lid, hanging on the crane before the transportation frame is being installed at University of Zurich. The side panel at the bottom includes the connectors for power and glass fibers. Coolant and dry air is supplied over a panel on the other side of the body.

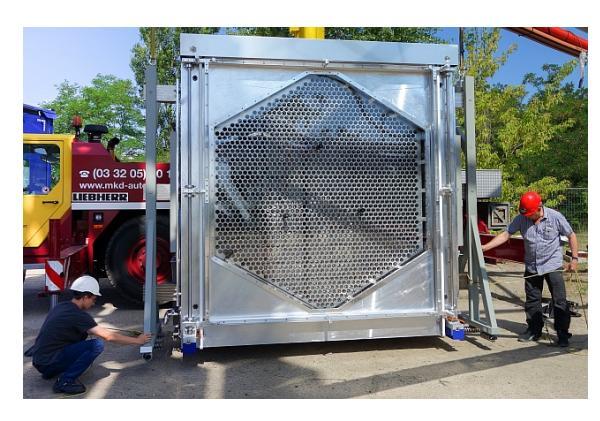
Figure 2: FlashCam body in Adlershof before installation. The lid has been opened to prevent accidental damage during transport and installation. The Plexiglas entrance window (still a non-UV transparent placeholder) was installed to study the system's mechanical stability under different elevation angles, as well as the cooling system under realistic conditions with a nearsealed body.

End of June the body without the readout and detector electronics was transported to the MST prototype structure in Adlershof, Berlin for mechanical and electrical tests. Figure 2 shows the camera body with the transportation frame and opened lid in Adlershof before being mounted into the camera frame of the MST prototype structure. The camera is installed with the help of a sledge system, which allows an easy and safe installation and removing of the camera (Figure 3). The excellent teamwork of the two teams from the University of Zurich and from DESY Zeuthen (figure 4) permitted a quick and easy installation of the camera.

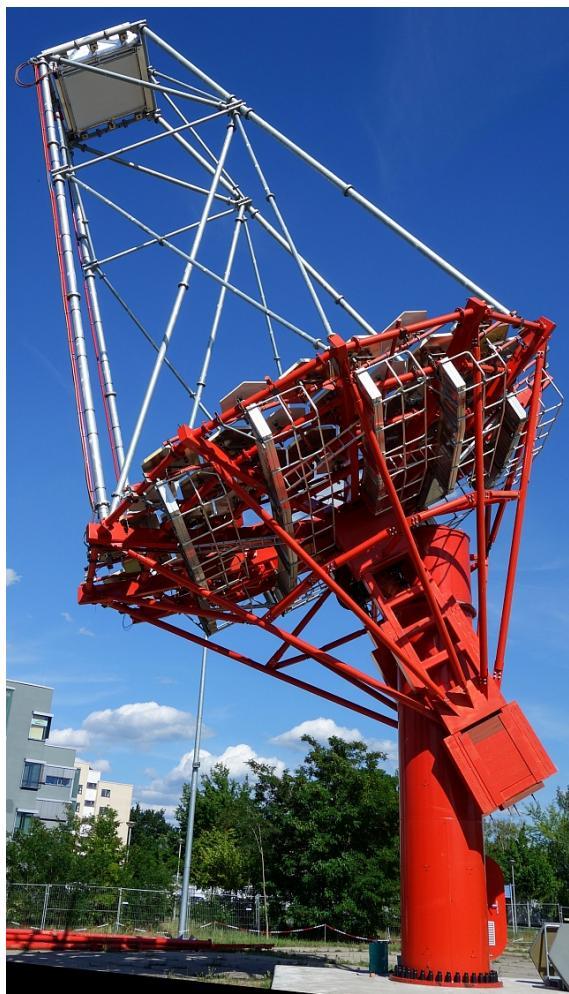
Figure 5: Driving of the telescope into its zenith position. The camera lid is closed and the installed detector modules are read out for offline investigation of possible light leaking and noise pick-up.

For this, the camera was connected to a simple pump system (without heat exchanger) and was moved to different elevation angles. The installation of two photomultiplier modules with 12 PMTs each and a readout crate was used to determine the light tightness of the camera under different elevation angles (figure 5) and also to investigate a possible noise pick-up from the drive system (figure 6). The comparison of the light tightness measurements to the lab values shows that the body is only slightly leaking when the camera backside faces directly the sun. This is understood and is no issue for night measurements but will still be corrected for the pre-production series. A first analysis of the data shows no noise pick-up from the drive.

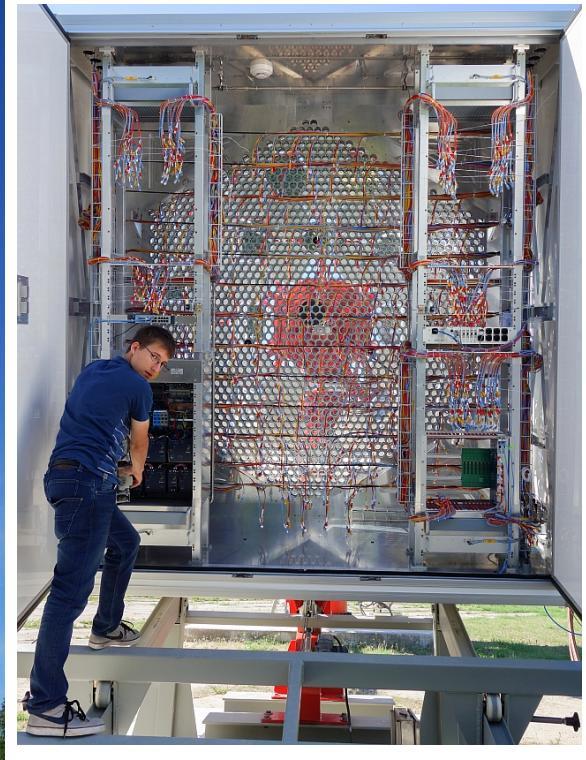
Figure 6: Camera rear doors open. The safety and power cabinet at the left lower rack position is being inspected. The slow control drawer is installed at the middle of the right rack. Installed at the top and bottom positions of the two racks are the fan drawers and the heat exchangers. One empty readout crate is also installed at the bottom of the right rack.
